Inspection Report

Condo Sample

All In One Home Inspection LLC

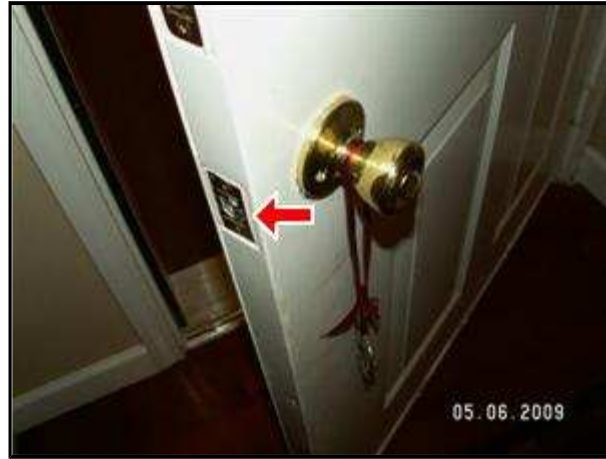
2.5 Picture 1

(1) The door latch sticks open causing the door to not latch or lock closed. The bolt probably needs lubrication to work properly. Otherwise evaluation and repair is recommended by a qualified person, door contractor or locksmith for security.

(1) The door latch sticks open causing the door to not latch or lock closed. The bolt probably needs lubrication to work properly. Otherwise evaluation and repair is recommended by a qualified person, door contractor or locksmith for security.

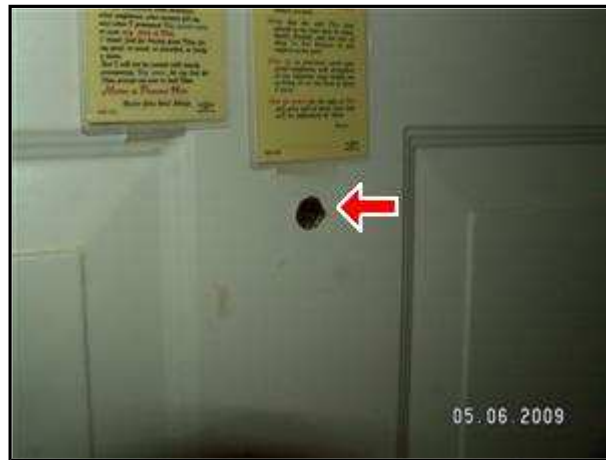
2.5 Picture 2

(2) The cover plate is missing from the "peep" hole viewer. Replace the cover plate for privacy and security.

(2) The cover plate is missing from the "peep" hole viewer. Replace the cover plate for privacy and security.

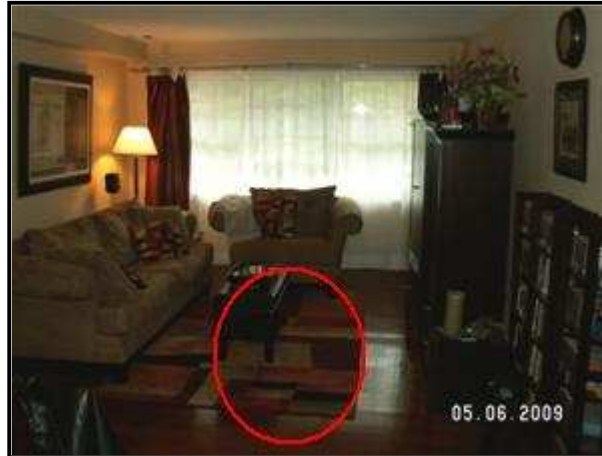
5.2.B Picture 1

The living room floor is crowned towards the middle. Evaluation and repair by a qualified flooring contractor if desired. Get quotes from several contractors to understand estimated costs.

The living room floor is crowned towards the middle. Evaluation and repair by a qualified flooring contractor if desired. Get quotes from several contractors to understand estimated costs.

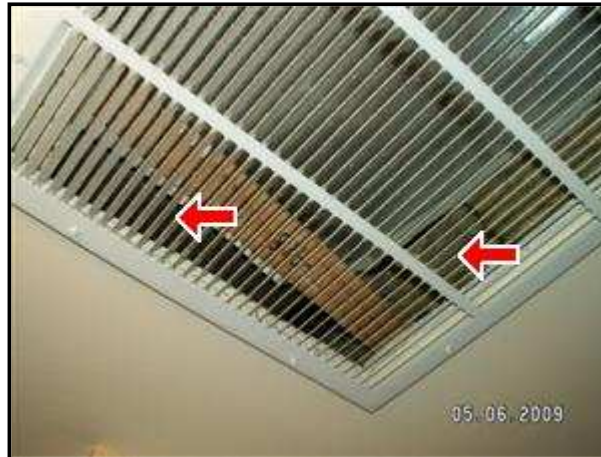
10.7 Picture 1

The return duct to the furnace is not attached at the intake register. The duct is drawing air from the interior spaces of walls and ceilings that contains dust, fiberglass, construction debris and other foreign contaminants. I recommend evaluation and repair by a qualified HVAC contractor.

The return duct to the furnace is not attached at the intake register. The duct is drawing air from the interior spaces of walls and ceilings that contains dust, fiberglass, construction debris and other foreign contaminants. I recommend evaluation and repair by a qualified HVAC contractor.
